2012 Annual Mining and Reclamation Report

Rio Tinto Eagle Mine LLC

March 15, 2013

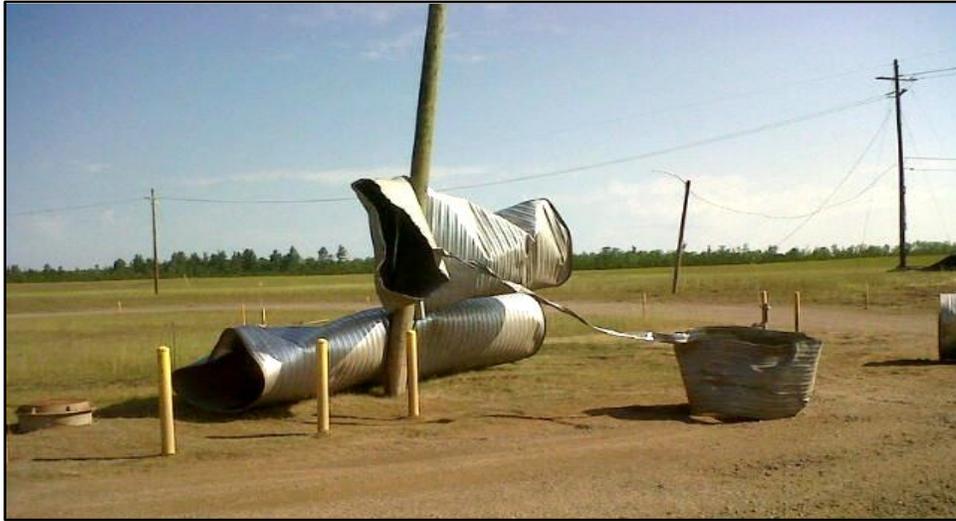
On June 8, 2012, severe weather resulted in minor damage at the Eagle Mine Site. An F1 tornado touched down at the northwest corner of the site and traveled east along the northern edge of the facility. During the event, all critical structures and equipment remained intact and operational. Minor damage occurred to the perimeter fence, an overhead door and roof corner at the WTP, siding of the pump houses, and the geo-membrane cover of the TWIS. In addition, ventilation tubes were carried from their staging location at the northwest corner of the facility and distributed throughout the site and outside the eastern fence line. All repairs to the TWIS, perimeter fence, and WTP were completed in 2012 and new siding was installed on the pump houses of the TDRSA and CWBs in Q1 2013.

Vent Tube Wrapped Around Light Pole

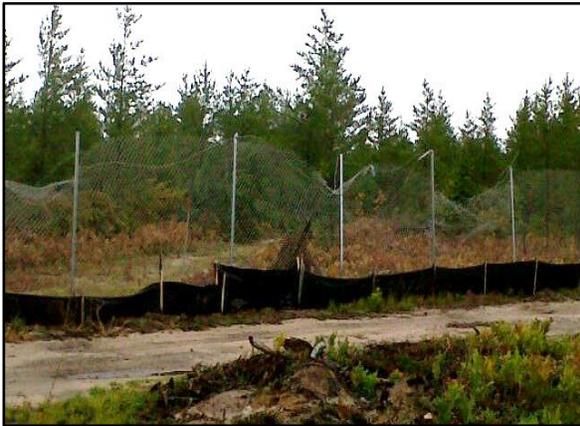
Damage to Perimeter Fence, June 2012

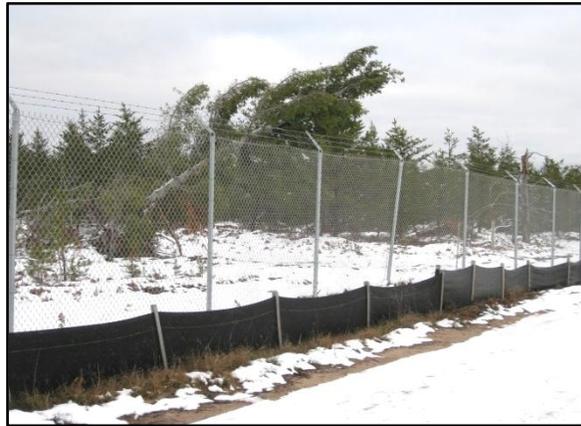
Repaired Perimeter Fence, November 2012

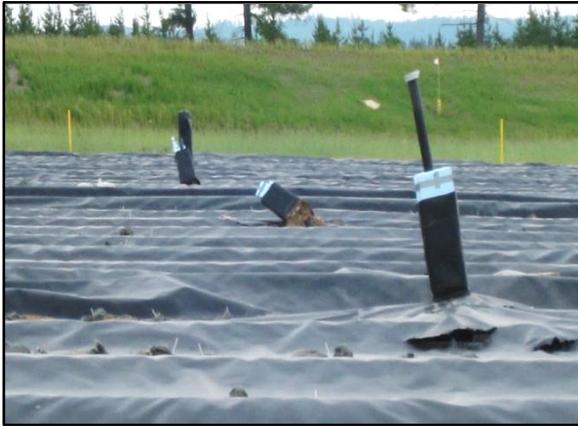
Damage to TWIS Geo-Membrane, June 2012

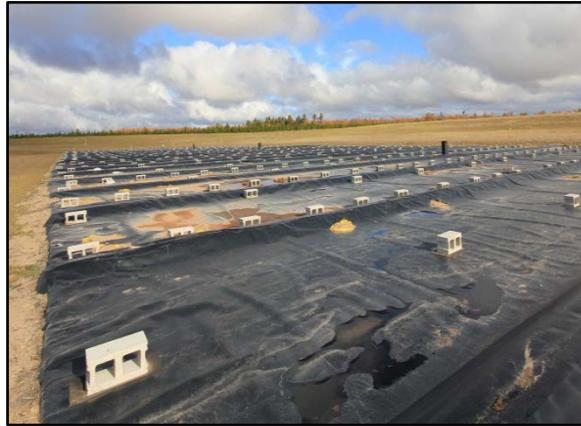
Repaired TWIS Geo-Membrane, October 2012

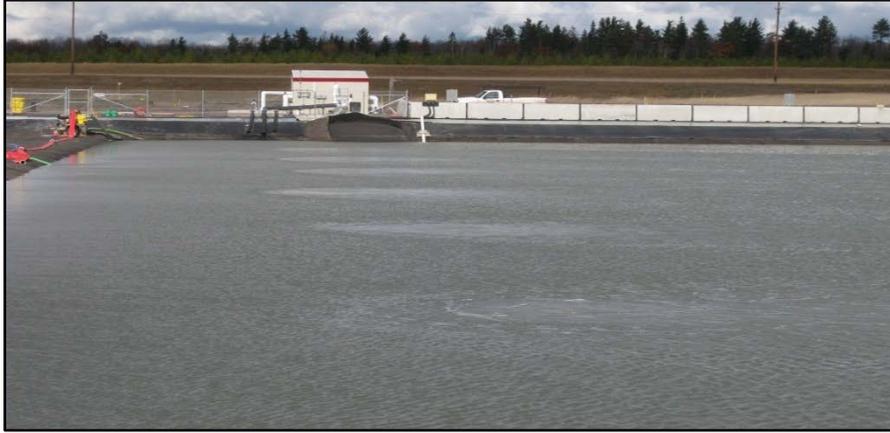
During the 2012 construction season, aerators were installed to minimize ice formation, provide mixing for improved WTP operations, prevent excessive sediment deposition, and assist in optimizing water quality before treatment from the underground operations. Two rows of six aerators were installed along the east and west sides of each basin, for a total of 12 per CWB.

Installed Diffusers, October 2012

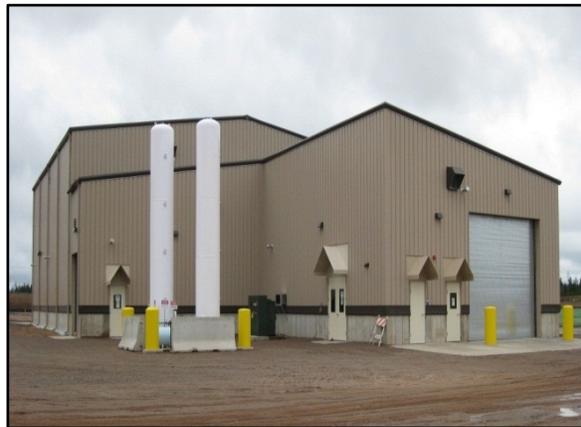
The truck wash was partially commissioned in 2012, with the manual bay of the truck wash currently being used to wash vehicles prior to leaving the contact area. Full operation of the automated system is expected in early 2013.

Truck Wash – Interior View, April 2012

Truck Wash – Exterior View, April 2012

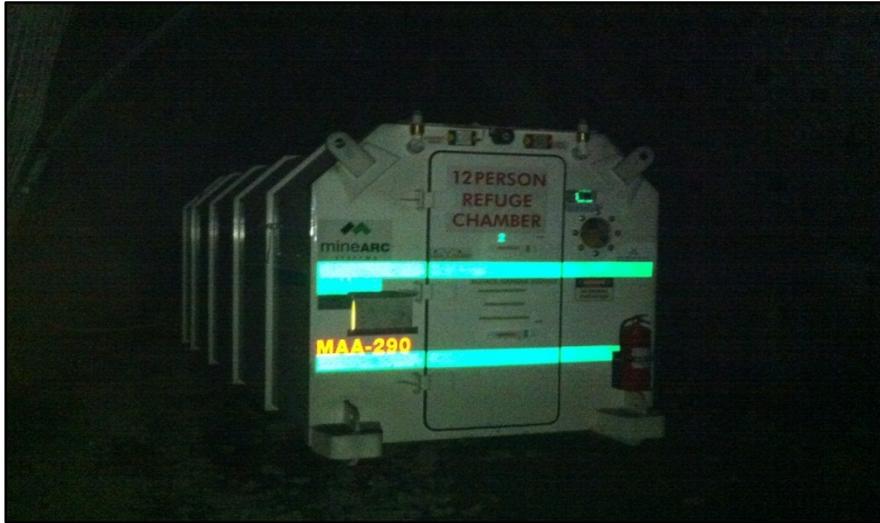
Three 12 person, 36-hour self-contained, Mine Arc refuge chambers were placed underground in 2012. They are currently located in muckbay No. 2, muckbay No. 5, and 265 level stope access 1665. Each unit is inspected on a weekly basis with a more robust inspection completed three times per year.

Mine Refuge Chamber, June 2012

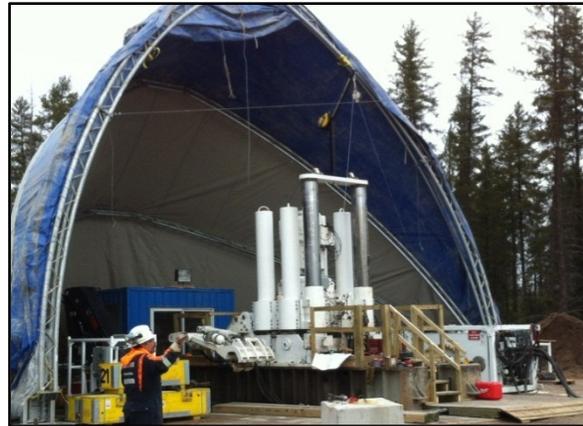
Raise bore drilling contractor, Cementation, also mobilized in November 2012 to complete the pilot hole and reaming of the mine air ventilation exhaust and emergency egress/ventilation intake. Drilling of the initial pilot hole for the emergency egress/ventilation intake began in late December 2012 and is 15” in diameter. Once the pilot hole is completed in early 2013, the drill bit will be replaced with a reamer bit that is 4.5 m (14.9 ft) in diameter which bores the hole from the bottom up. The process will then be repeated for the ventilation exhaust raise bore.

Raise Bore Drill, Dec. 2012

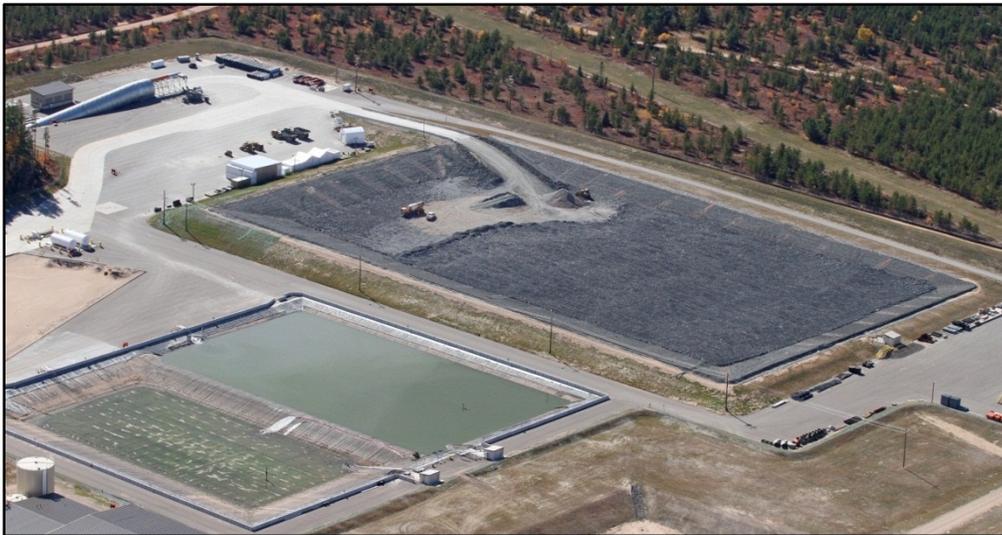
The initial phase of rock placement on the TDRSA required that the first two feet of material placed in the TDRSA was a 3 to 4 inch particle size. Therefore, a portable crusher was utilized and a two foot base layer of crushed development rock was graded across the entire floor area. The base layer was not completed in 2011, therefore crushing operations continued through March 2012. Approximately 11,888 m³ (34,641 t) of development rock was crushed in 2012 in order to complete the two foot base layer.

TDRSA and CWBs, October 2012

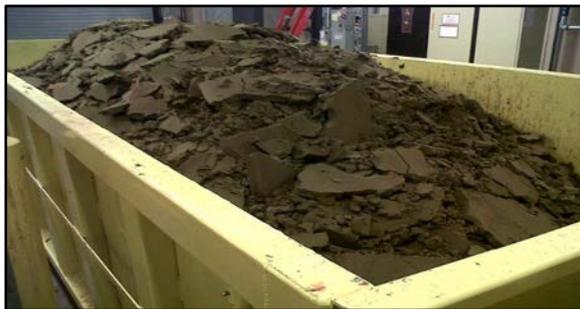
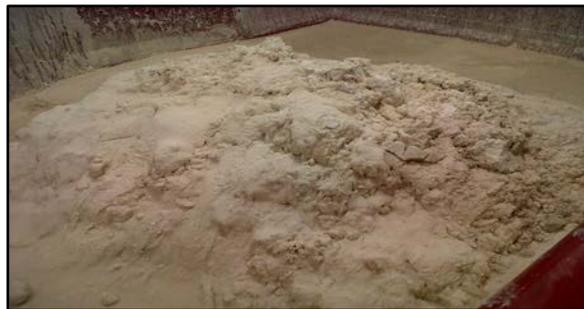
The water treatment process generates two waste streams; filter press solids and crystallizer solids. The filter press waste stream is dewatered solids from the multi-flow treatment process and is primarily comprised of calcium and magnesium, while the crystallizer waste is essentially sodium chloride. A waste characterization program was initiated in 2012 as required by the Marquette County Landfill in order to dispose of the solids at their facility. All characterization results indicated the waste was non-hazardous. Therefore, the Marquette County Landfill accepted approximately 128 tons of filter press waste and 336 tons of crystallizer waste for disposal in 2012.

Filter Press Waste, March 2012

Crystallizer Waste, March 2012

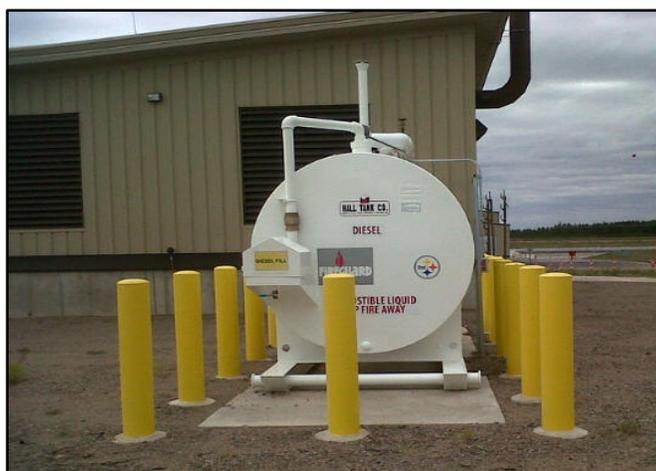
Rio Tinto has an equipment fueling area for underground equipment that consists of two identical 20,000-gallon Class II diesel aboveground storage tanks (ASTs) and one 560-gallon gasoline AST. Although the tanks are in place, they are not currently operational. One of the 20,000 gallon tanks was temporarily certified, pending final installation of electrical systems, for use on March 1, 2012 by the MDEQ's Hazardous Materials Storage Inspector and filled with fuel, but is not currently in use. In addition, on July 5, 2012, final certification was granted by the MDEQ's Hazardous Materials Storage Inspector for the 1,700-gallon day tank used to fuel the standby generator located in the powerhouse.

Certified 1,700 gallon day tank, July 2012

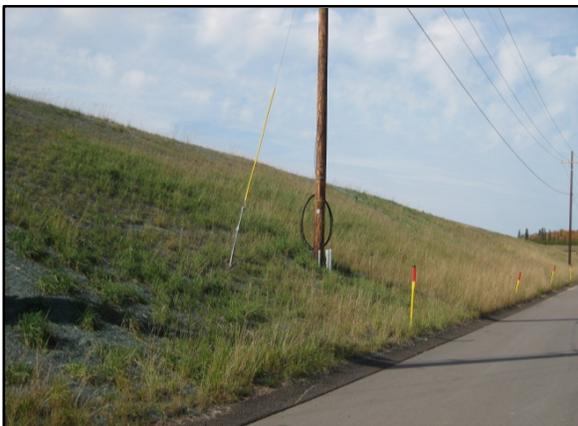
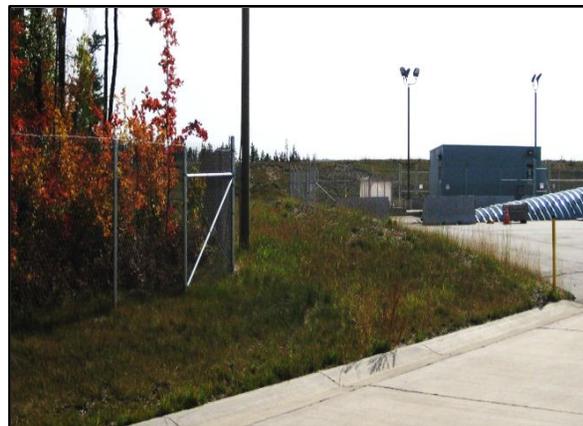
Inspections conducted in 2012 did not uncover any issues with the integrity of the berms. Seeding and mulching that occurred late in the 2011 construction season did result in vegetative growth on the berms near the CWBs, but was unsuccessful on the exterior berms of the TDRSA. In spring 2012, top soil, seed, and mulch were reapplied to the TDRSA berms and added to the berms south of the portal to further reduce soil erosion and sedimentation in the CWBs. The efforts were successful and vegetative growth is now present at both locations.

TDRSA Berm, October 2012

Berm South of Portal, October 2012
