**Subject: Annual Mining and Reclamation Report, Eagle Mine, LLC
Nonferrous Metallic Mineral Mining Permit (MP 01 2010), Humboldt Mill**

2014 Annual Mining and Reclamation Report Humboldt Mill Mine Permit MP 01 2010

March 15, 2015

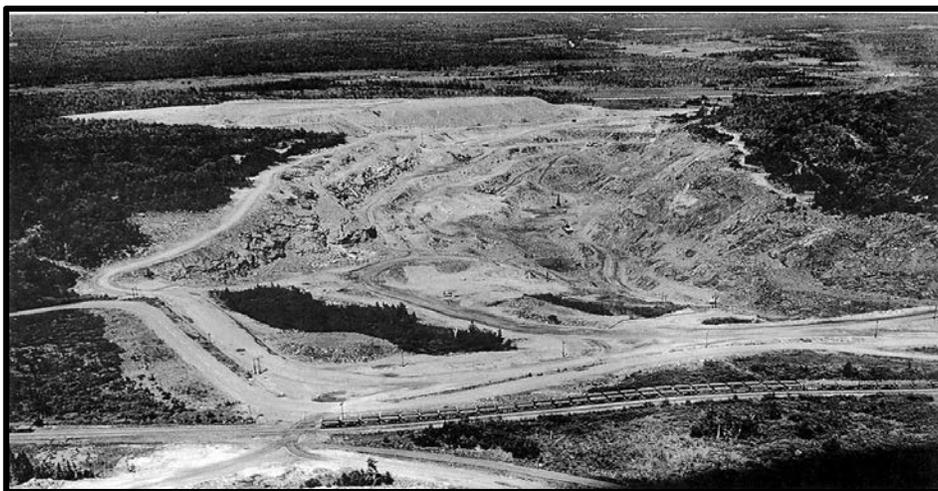
Humboldt Open Pit Mine, June 1967

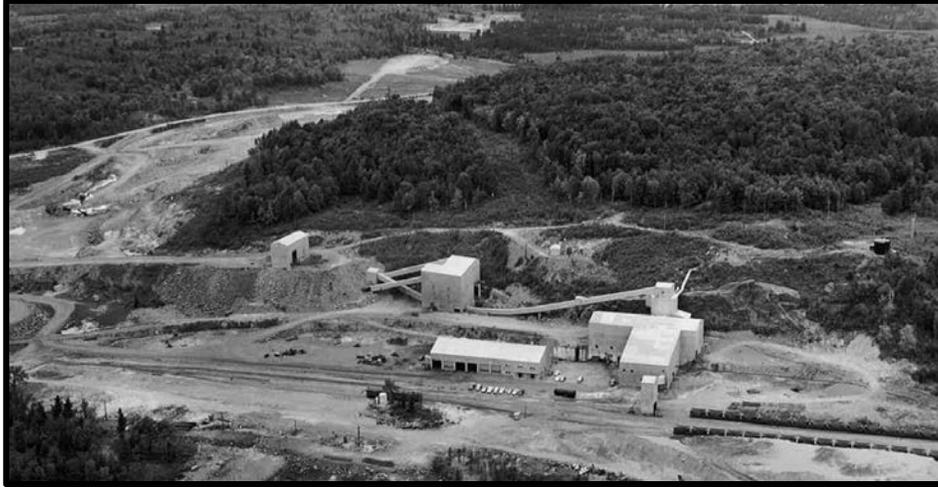
Adjacent to the Humboldt Mine, the ore processing facility incorporated crushing, grinding, and flotation units to concentrate the iron ore. A grate kiln pellet facility was added in 1960. The mill operated until about 1970. At that time the mine was closed but the mill was converted to a hematite concentrate regrind with upgraded circuits using two ball mills and an elutriation process. The pellet facility continued to operate, processing the hematite concentrate and excess concentrate from the nearby Republic Mine. Operations continued until about 1979 when ore deliveries from Republic ceased.

Humboldt Mill Processing Plant, circa 1950's

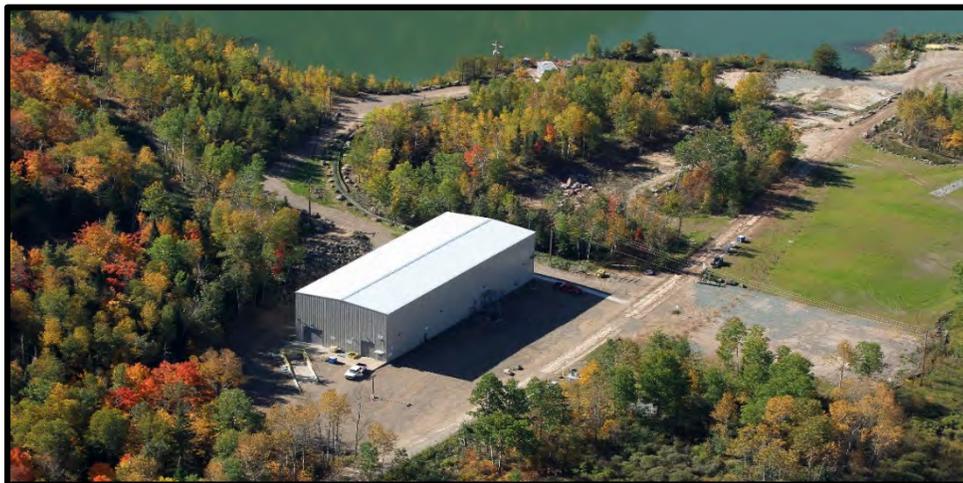
Water Treatment Plant, September 2014

In December 2013, final WTP designs were submitted to MDEQ for review, and approval. Construction of the WTP commenced in September 2013. Commissioning began in June 2014 and the first discharge of treated water to the wetland occurred on August 25, 2014. All documents and information required per the State of Michigan issued National Pollutant Discharge Elimination System (NPDES) Permit (MI0058649) were submitted, and if applicable, approved by MDEQ.

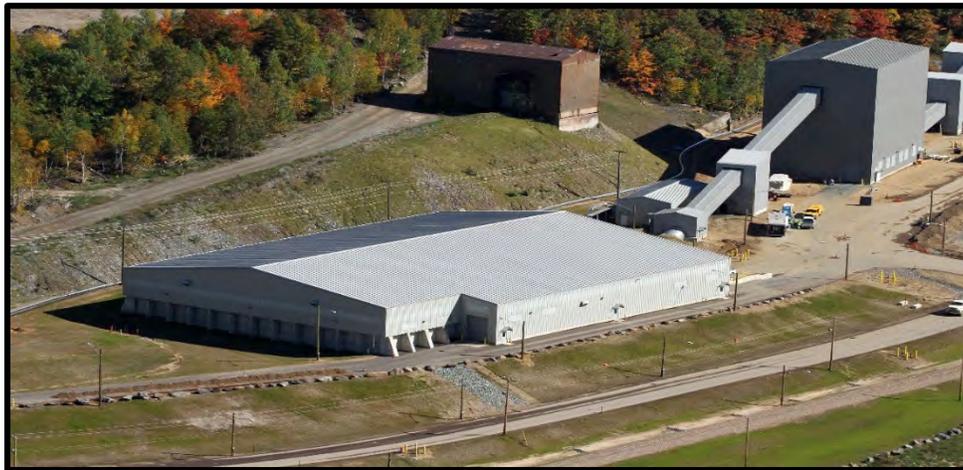
Coarse Ore Storage Area, September 2014

The COSA is a 34,500 square foot facility that is used to store mined ore that has been transported from the mine site and is awaiting processing. The COSA is an enclosed building with the exception of two roll-up doors on the east and west ends of the building that allows entrance and exit of the haul trucks off-loading ore from the Eagle Mine Site and one additional roll-up door on the east end that allows additional access to the facility. The COSA contains a rock breaker that is mounted adjacent to the primary crusher and is used to reduce oversized rocks entering the system. The primary jaw crusher reduces the size of the ore from run-of-mine to minus 100 millimeters and is equipped with a water spray to suppress dust.

In addition, in accordance with mining permit condition E-4, the COSA is equipped with a water hose to manually wash the ore trucks, if necessary, prior to leaving the facility. All wash water is collected in the COSA sump and pumped to the HTDF via the storm drain, for eventual treatment in the water treatment facility.

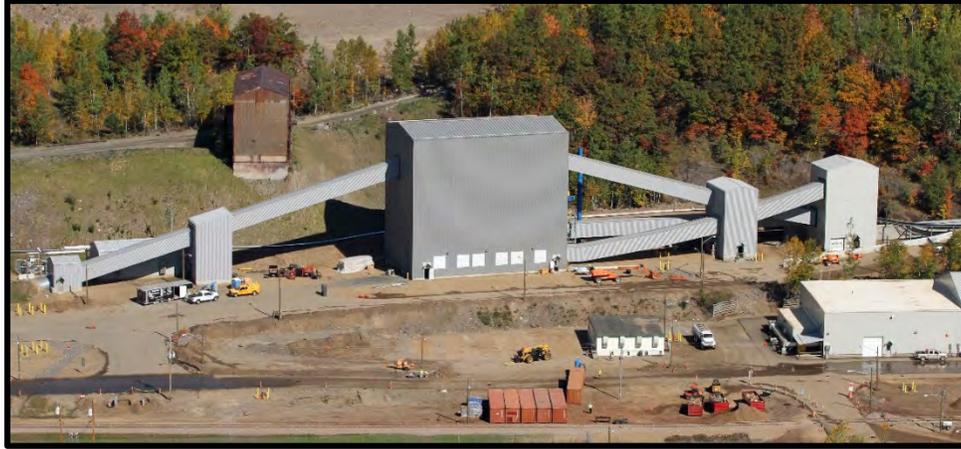
Crushing Circuit – Secondary & Tertiary Crushers and Transfer Building, September 2014

Crushed material is conveyed from the primary crusher to the 6,000 square foot secondary crusher building via an enclosed conveyor. In the secondary crusher, the primary crushed ore is screened with pieces greater than minus 12 mm in size being sent to the secondary cone crusher. Pieces smaller than minus 12 mm are sent to the transfer building discharge conveyor. After crushing, the material is again screened and if found to be oversized is sent to the tertiary cone crusher. Once material is crushed to less than minus 12 mm in size it is sent to the covered discharge conveyor to the fine ore bins. All air exhausted from the secondary crusher building is vented through a baghouse dust collector. The equipment is maintained in accordance with manufacturer's specifications and the Humboldt Mill Permit to Install (405-08) issued by the MDEQ Air Quality Division.

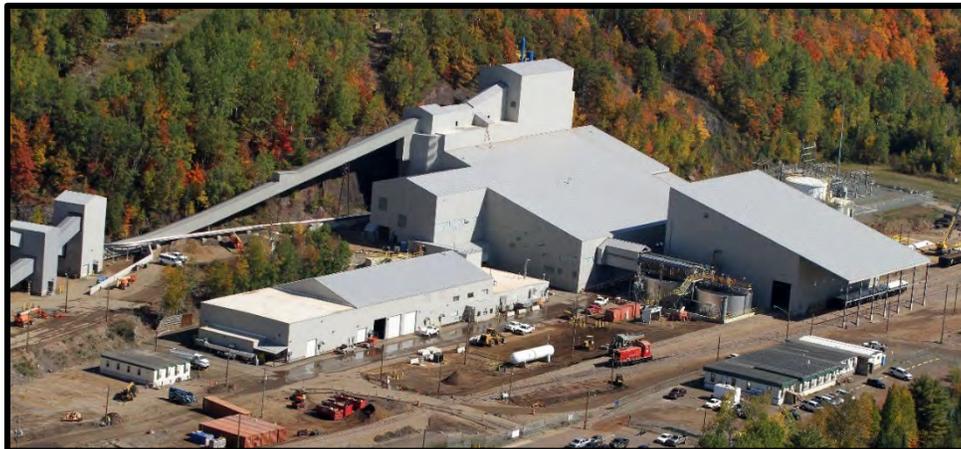
Concentrator and Concentrate Load-out Buildings, September 2014

The concentrator building is a 53,000 square foot facility in which ore processing occurs. The fine ore is made into a slurry by addition of water before entering the grinding process which consists of two refurbished ball mills which grind the ore to a size of 80% passing 80 microns. The material then enters a flotation process where the copper and nickel are separated. The concentrate from the flotation circuits enters the concentrate thickeners where it is thickened and pumped to agitated stock tanks, one for nickel and one for copper. Concentrate from the stock tanks is pumped to automatic pressure filters where the moisture content will be reduced to approximately 15%. The concentrate filter cake from the pressure filters discharge directly to the concentrate load out building.

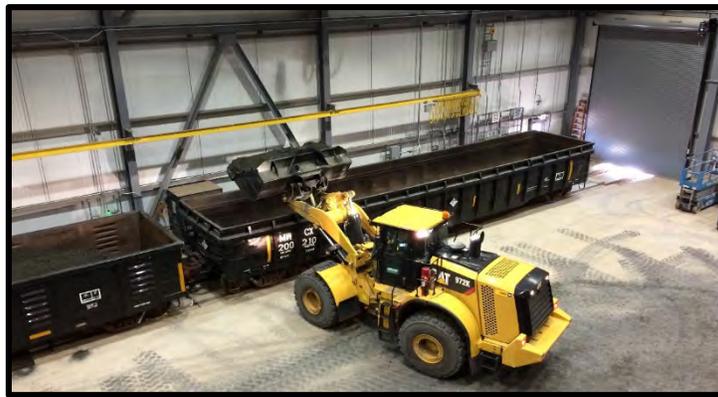
Loading Concentrate into Railcars, September 2014

The CLO is a 17,000 square foot facility in which the nickel and copper concentrate is stored until it is loaded into railcars. The building is fully enclosed with the exception of two roll-up doors on the east and west ends that allow for the entrance and exit of rail cars. Railcars are loaded using front end loaders in accordance with the Concentrate Loadout Operations Standard Operating Procedure (SOP). All railcars are covered and as noted in the CLO SOP, cleaned of dust and debris, using a broom, prior to leaving the facility.

The nickel sulfide concentrate, stored in the CLO, has been identified as potentially self-heating. Operators closely monitor the material for oxidation using an infrared laser gun thermometer. Material exhibiting signs of self-heating is immediately compacted or exposed and spread out depending on the situation.

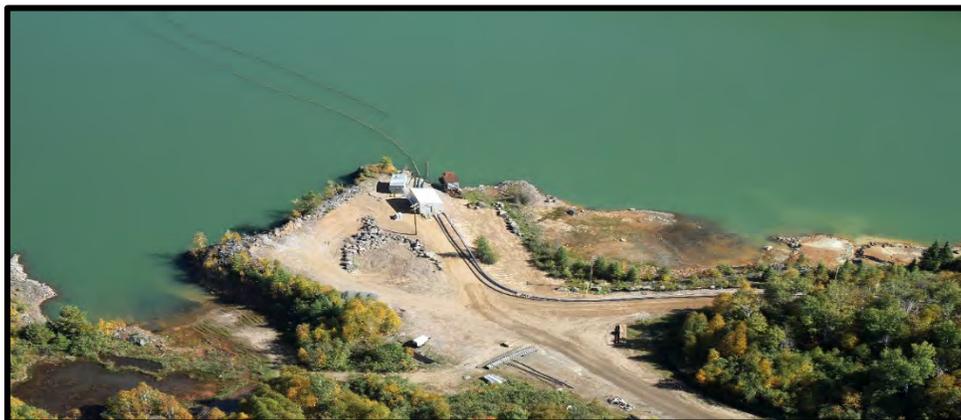
HTDF Tailings Management, September 2014

From the flotation circuit, tailings is dewatered to approximately 60% solids. Tailings slurry is then pumped via double walled high density polyethylene (HDPE) pipe to the HTDF where it is sub-aqueously disposed to one of three discharge points. Disposal of tailings in the HTDF is authorized by the Inland Lakes and Streams Permit that was originally issued in 2010 and renewed in September 2014. The tailings flow rate is continually monitored and recorded in accordance with mining permit condition F-8.

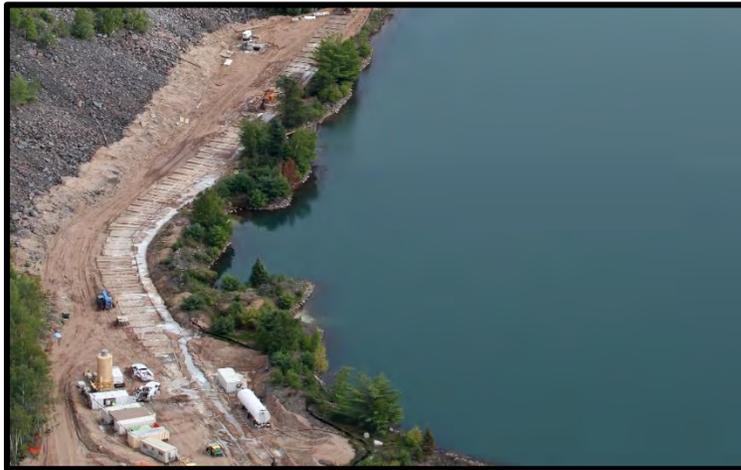
Cut-off Wall Construction, September 2013

Construction of the cut-off wall was performed between August 2012 and September 2013 and included both the installation of a soil bentonite slurry wall and grouting of high permeability material below that wall. The work was in accordance with the design and standards approved by MDEQ in May 2012. Hydraulic gradient performance testing was conducted by Golder and Associates and North Jackson Company. Based on the results of the performance testing, MDEQ approved the cutoff wall for operations on March 23, 2014.

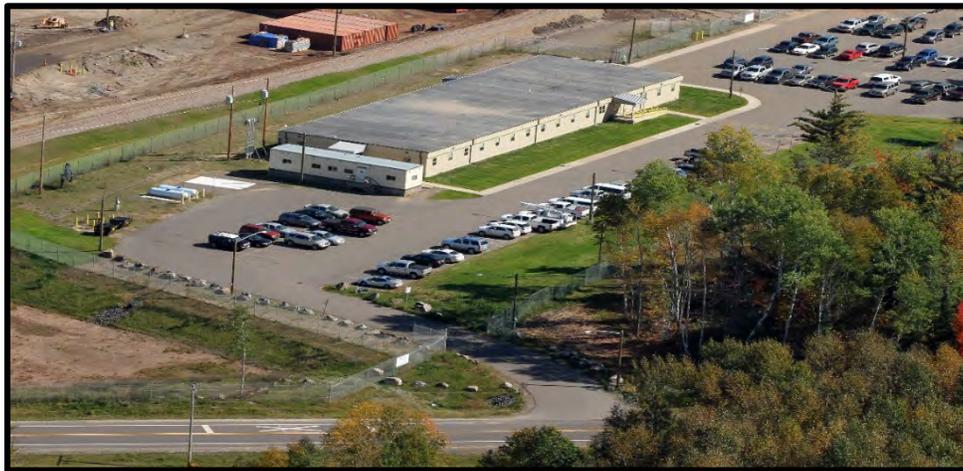
Eagle completed construction of ancillary facilities including the administrative building in 2012 and guard house, rail spur, catch basins, site grading, and paving in 2014. In addition, a permanent chain link fence delineating the property boundary was partially installed in 2013 and completed in the fall of 2014 after the conclusion of construction.

Administrative Office, September 2014

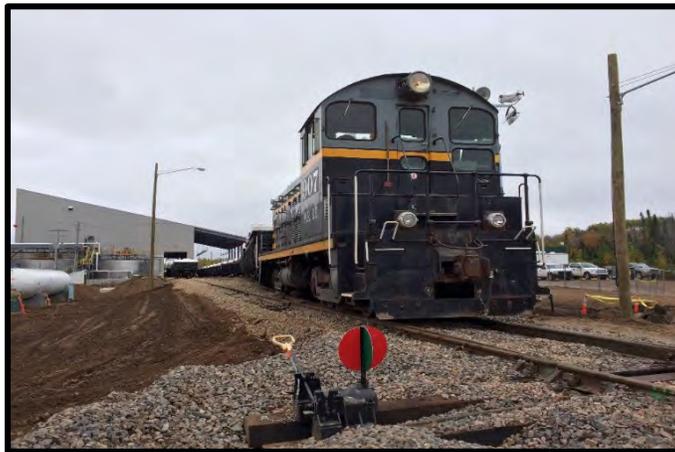
In 2014, 8,593 dry tonnes of copper and 28,742 dry tonnes of nickel were shipped offsite via rail. Mineral Range manages rail shipments from the Humboldt Mill to the Ishpeming Rail Yard and from there Canadian National (CN) transports the material to its final destination.

First rail cars leaving mill site, October 1, 2014

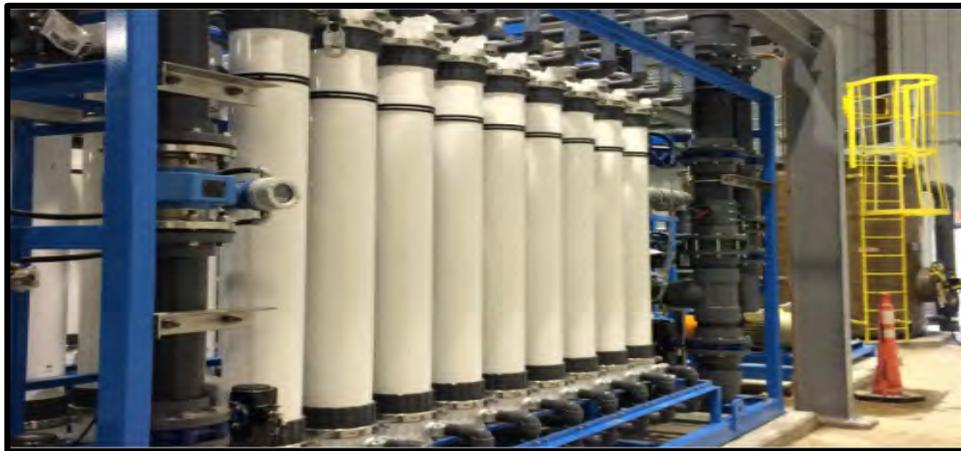
Water Treatment Plant Ultrafiltration Units, August 2014

The water treatment process generates one waste stream; filter press. The filter press waste stream is dewatered solids from the clarifier and is primarily comprised of iron, calcium, and magnesium. Waste characterization samples are required by the landfill prior to acceptance of the material. Samples from the filter press waste stream were sent to ALS Laboratory for analysis and results indicate the waste stream is non-hazardous. From September through December 2014 approximately 14 tonnes of filter press waste was disposed at the Marquette County Landfill.

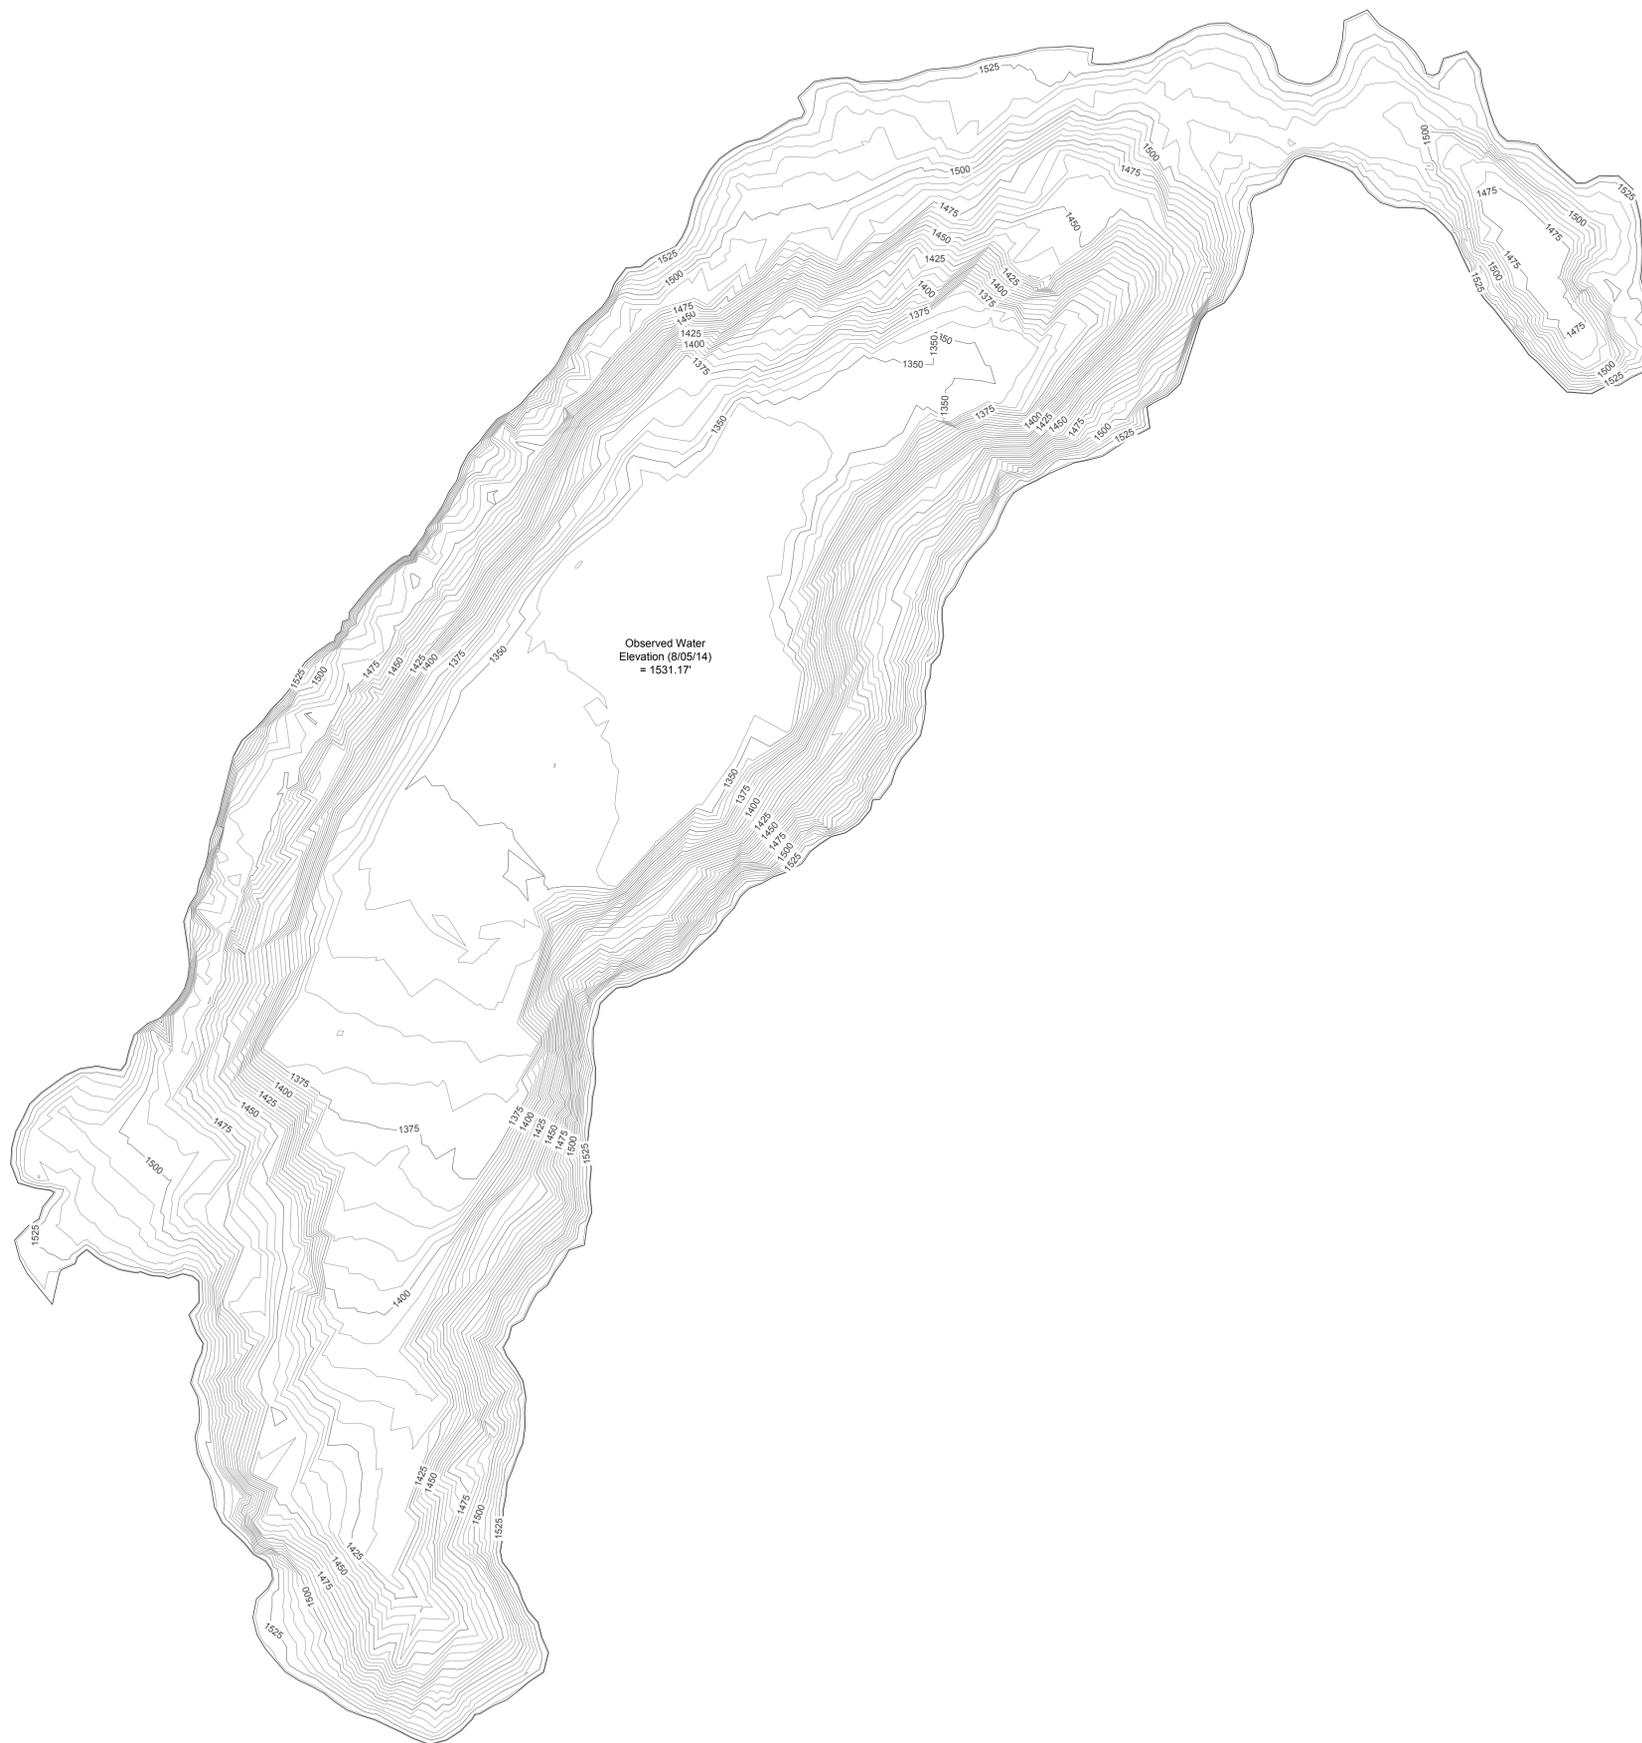
SHEET NUMBER:
1.0

Eagle Mine - Humboldt Mill
2014 Bathymetric Survey
Champion, MI
Summer Baseline

In accordance with permit condition, F-7, an annual bathymetry survey was conducted in order to accurately monitor tailings placement and calculate changes in HTDF water storage. Since 2014 marked the start of operations, two surveys were completed; the first was a baseline survey conducted in the summer prior to the start of operations and a second was conducted in November after operations commenced. A copy of both bathymetry surveys are available in Appendix C.

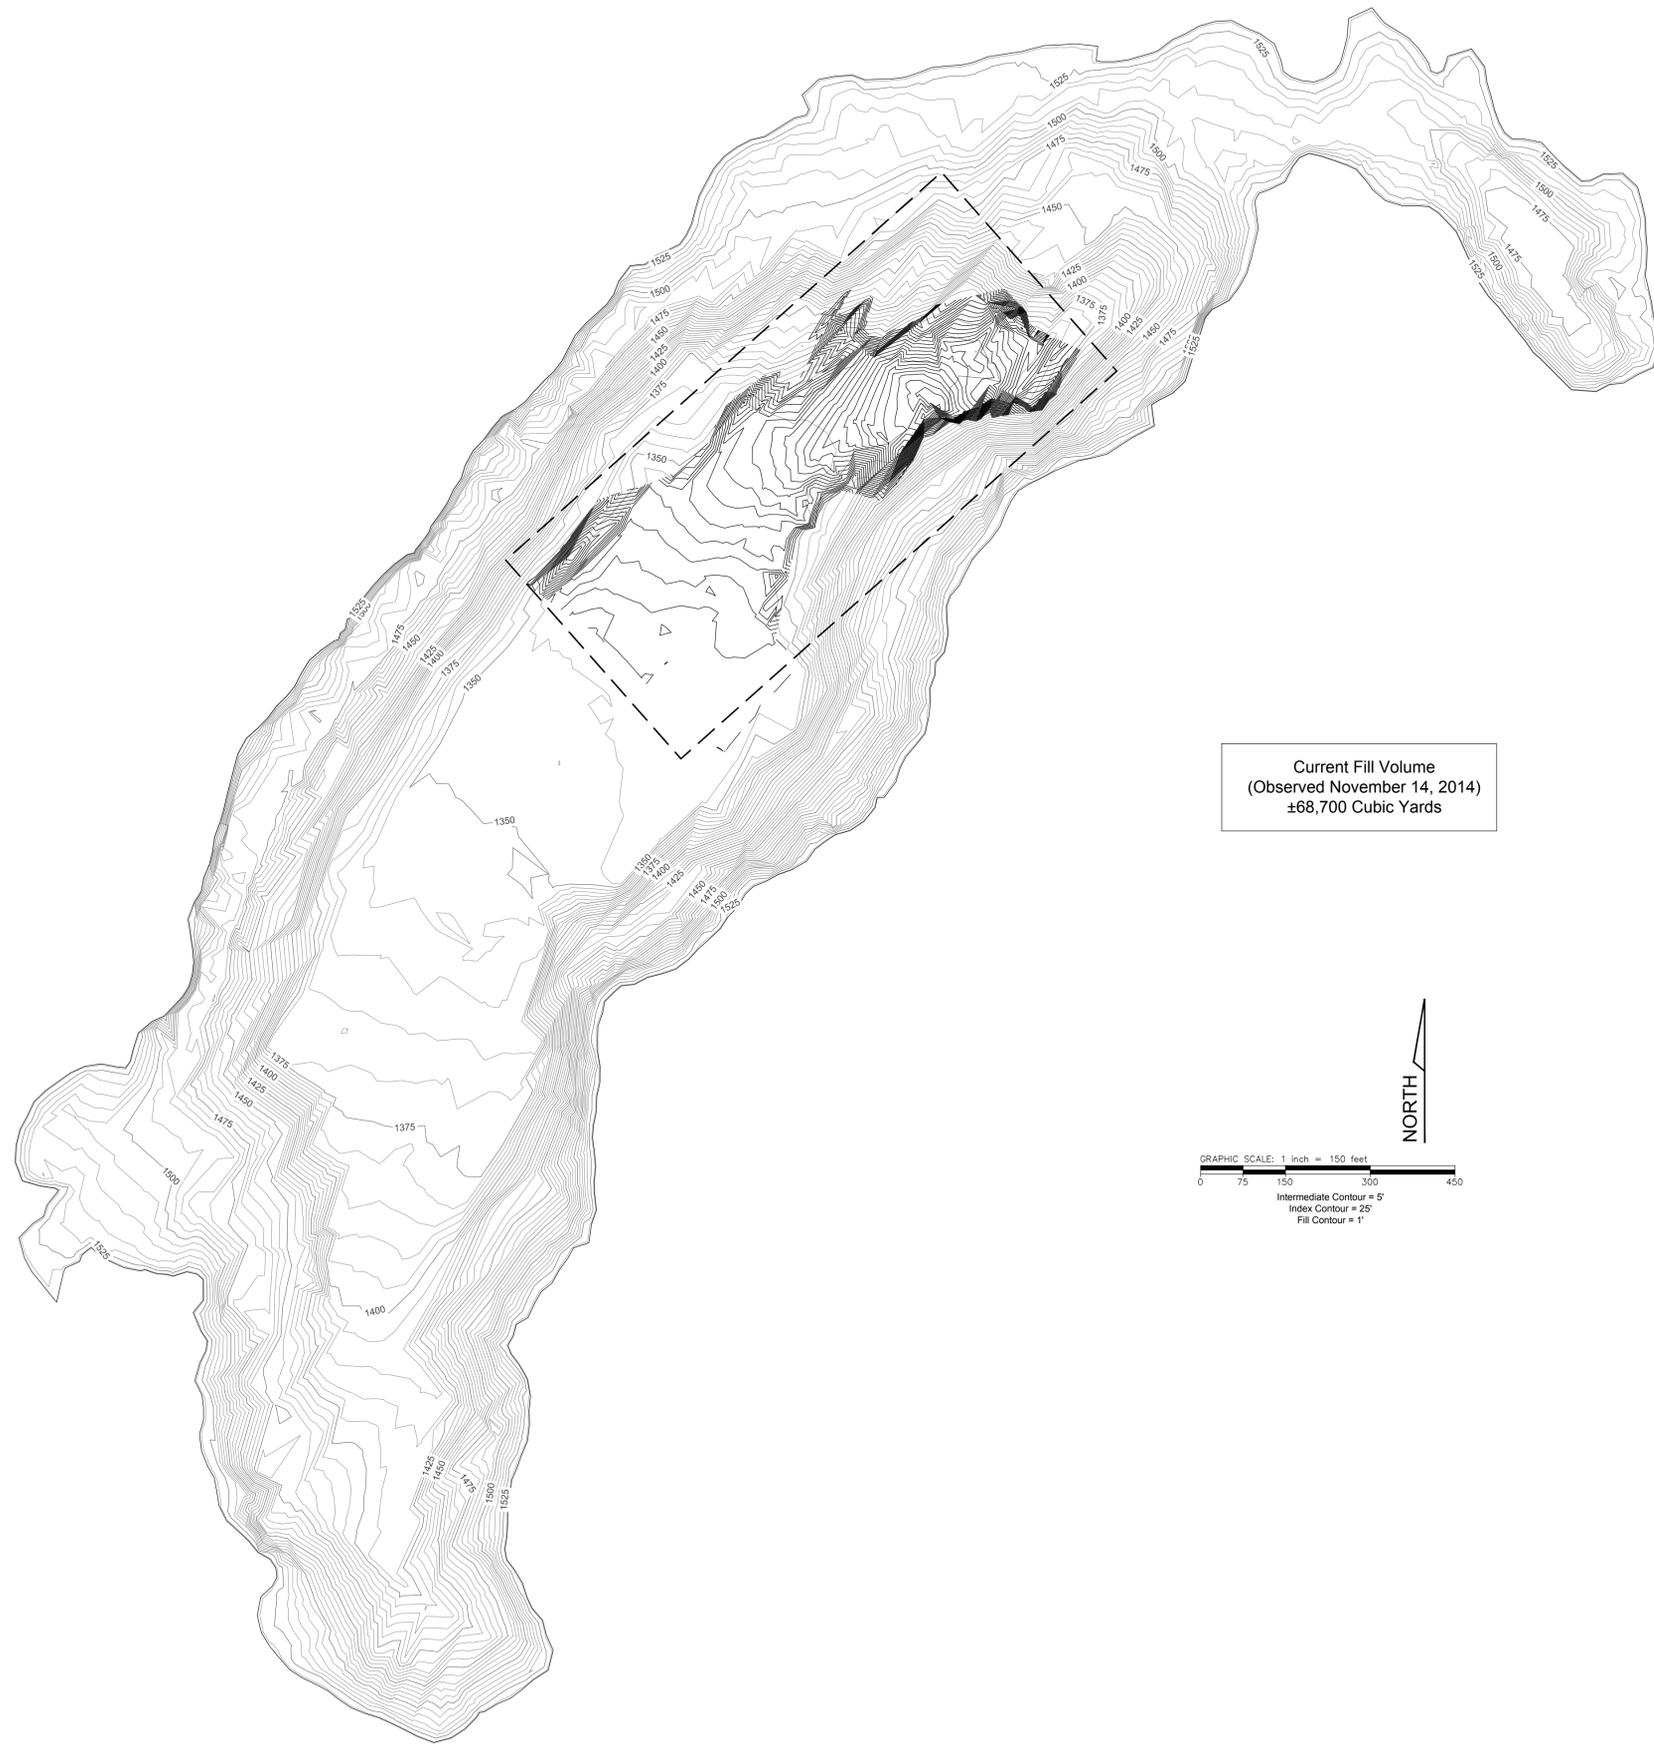
Current Fill Volume
(Observed November 14, 2014)
±68,700 Cubic Yards

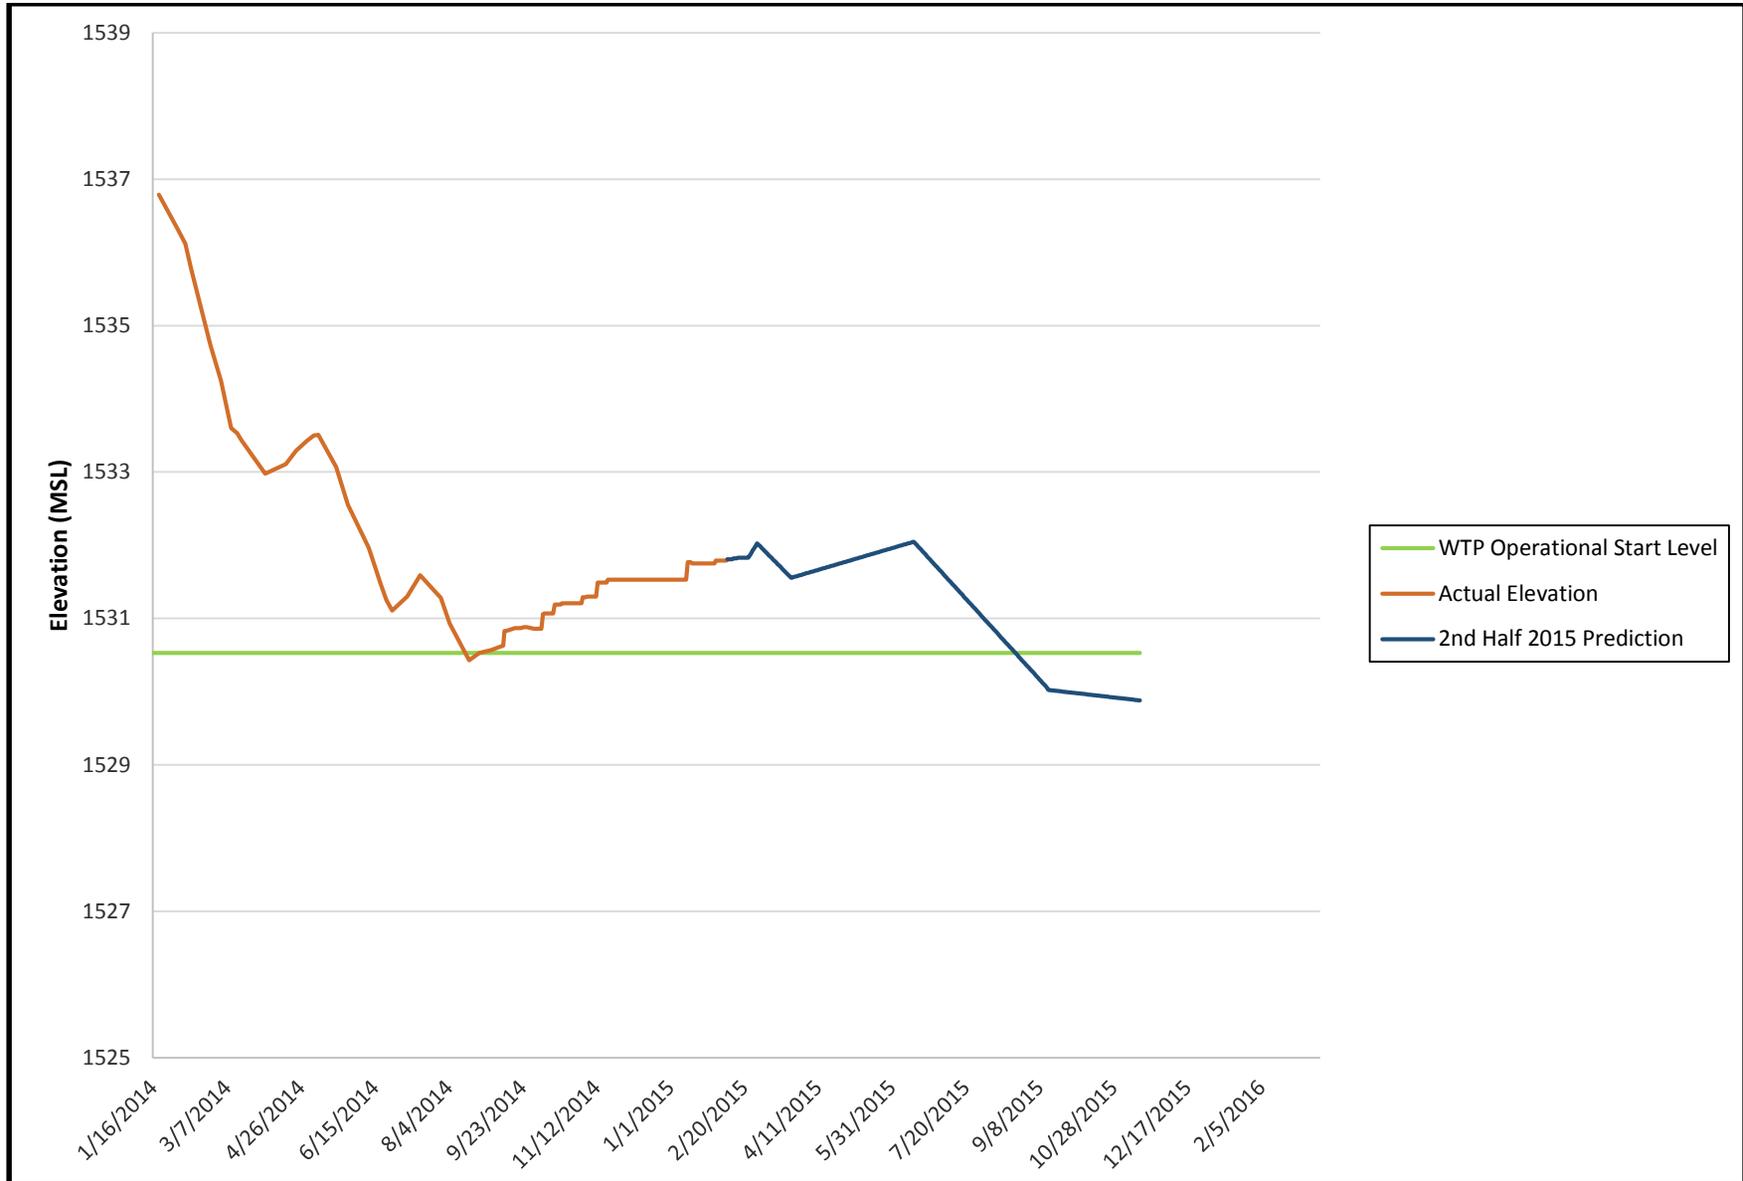
2014 Surface Water Elevations Water Balance and 2015 Predicted Water Levels Humboldt Mill

balance is updated on a quarterly basis to ensure the water level of the HTDF is managed in a manner that minimizes risk to the environment. Eagle intends to operate the HTDF at a water elevation between 1529 – 1534 MSL and has developed a water balance spreadsheet that takes into account historical seasonal precipitation and groundwater infiltration rates, calculated storm water runoff rates, process water use, and WTP discharge rates. This information is used to track HTDF water elevations, predict seasonal fluctuations in the HTDF water level and to help determine if operational adjustments are necessary. HTDF water levels are recorded at least weekly by Environmental Department staff and updated in the spreadsheet to ensure that the water balance is being maintained in the predicted manner. In the event that deviations in the predicted levels occur, a review of water inputs will be conducted to determine where the gap exists and what operational changes need to occur in order to maintain the predicted water level. A summary of the 2014 HTDF water levels and current water balance graph is included in Appendix D.

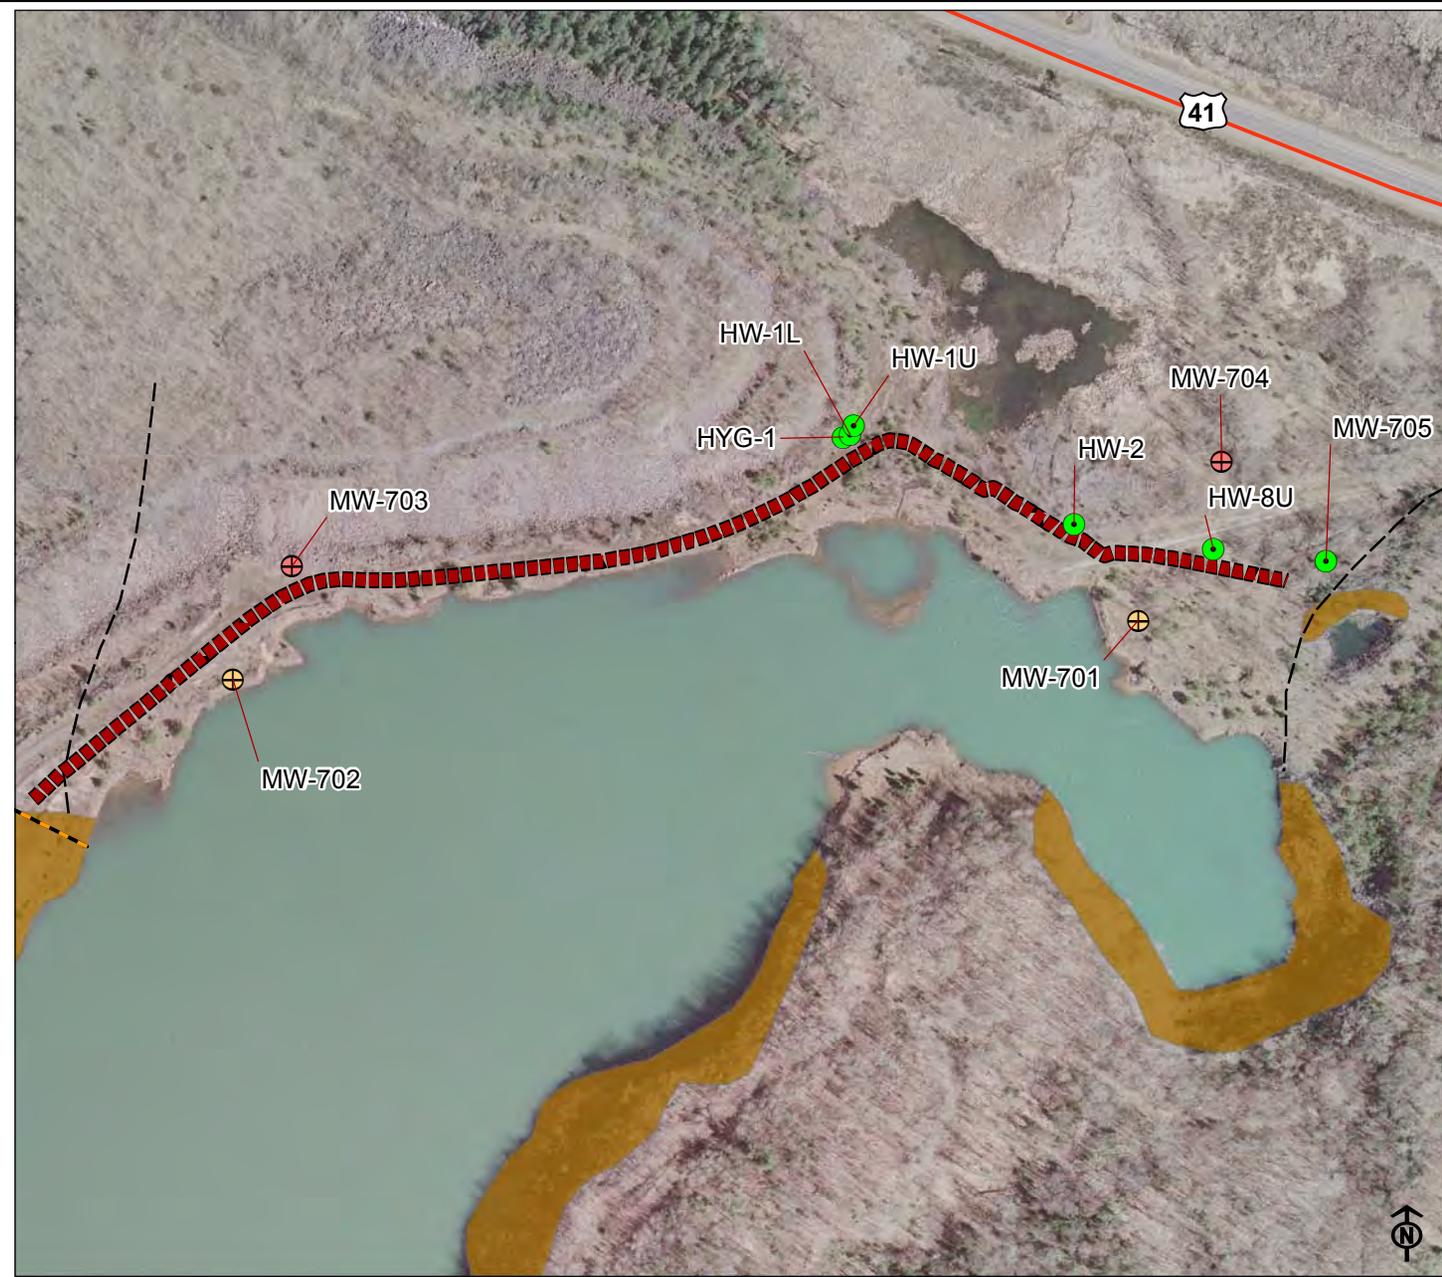
**CUT-OFF WALL
MONITORING WELL NETWORK
LOCATIONS**

Groundwater quality is monitored through a network of monitoring wells located inside the perimeter fence line of the mill site. A map of the well locations can be found in Appendix E. With the exception of a few wells that were installed in 2008, the majority of the wells located near the cut-off wall were installed from October 2013 through January 2014. Monitoring wells located near mill facilities were not installed until later, April through August 2014, due to construction activities occurring at locations selected for monitoring well installation.

Monitoring wells MW-701, MW-702, MW-703, MW-704, HYG-1, HW-2, HW-1U, HW-1L, HW-8U are instrumented with continuous water level meters and downloaded quarterly by Golder & Associates field technicians. Permit condition F-9 requires that water levels are continuously monitored in Wetland EE and the HTDF. A stilling well is being installed in the HTDF in the spring of 2015 in order to continuously monitor HTDF water levels. Currently water level readings are recorded on a weekly basis using a staff gage installed on the north end of the HTDF. A map of monitoring locations can be found in Appendix E.

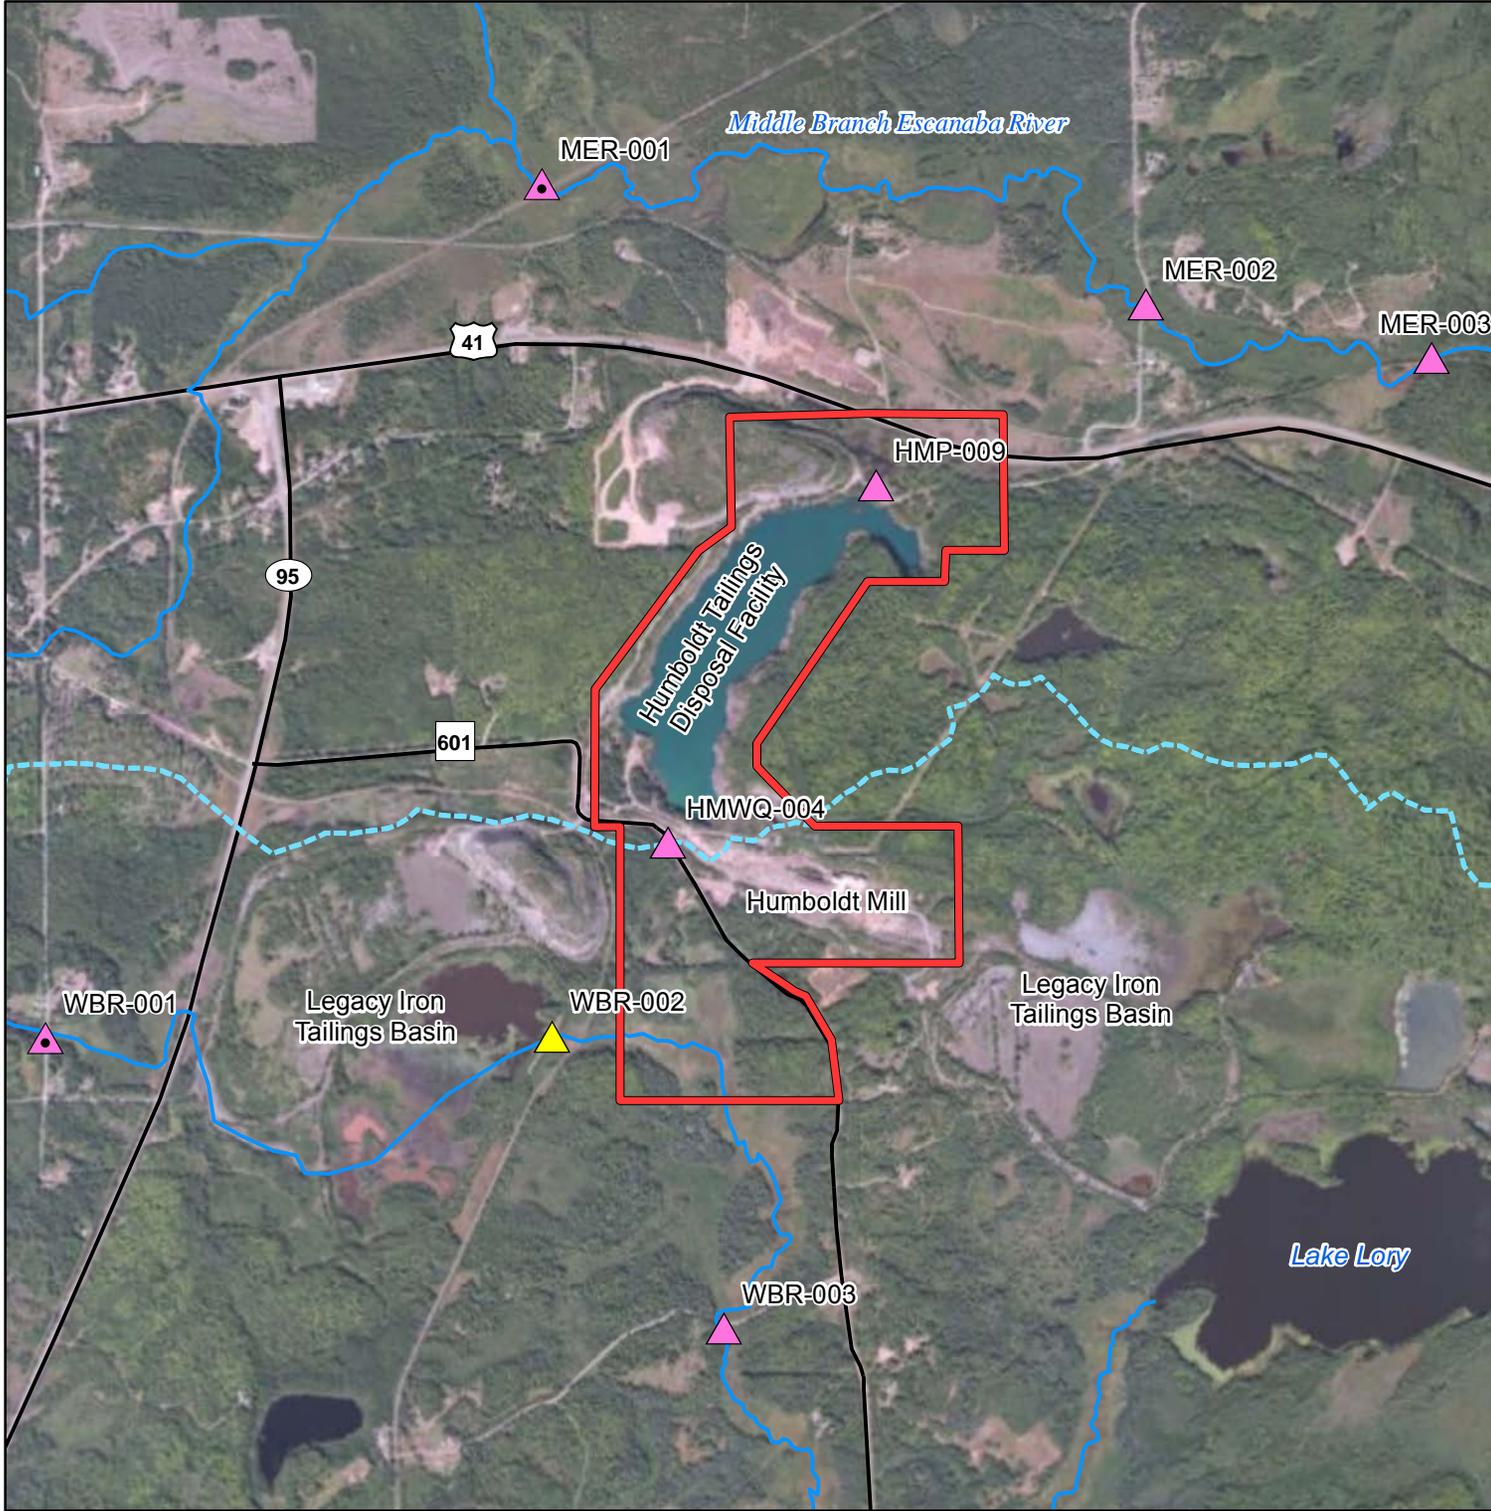
**HUMBOLDT MILL
PROPOSED SURFACE WATER AND
SEDIMENT MONITORING LOCATIONS**

In accordance with special permit condition, J-10, eight surface water monitoring locations are sampled on a quarterly basis. Four locations are associated with surface water resources in the subwatershed containing the HTDF and four are associated with the subwatershed of the milling facility. The monitoring locations in the subwatershed of the HTDF includes one location in Wetland EE and three locations on the Middle Branch of the Escanaba River, one of which, MER001, is outside the influence of the HTDF and is therefore considered a reference monitoring location. The monitoring locations in the subwatershed of the mill includes a drainage structure downgradient of the mill and three locations on the Black River. Again one of the three locations, WBR001, on the Black River is outside the influence of the milling facility and is considered a reference monitoring point for the subwatershed containing the mill. A map of the surface water sampling locations is found in Appendix G.
